## BELZONA PROVEN PROTECTION ON TURBINE RUNNER

Francis Turbine runner for a Hydro Electric Plant in Africa.

Coating protection required to deal with anticipated Erosion and Corrosion.

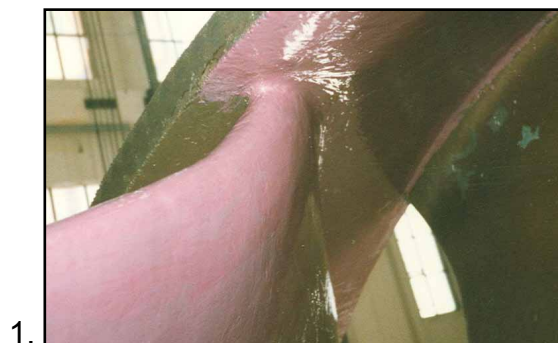
1. First coat
2. Second Coat applied
3. Completed Application
4. Coating after 20 years in service

Surface Preparation and Application was carried out accordance with the relevant IFU and in line with Belzona Know-How System Leaflet CEP-3.

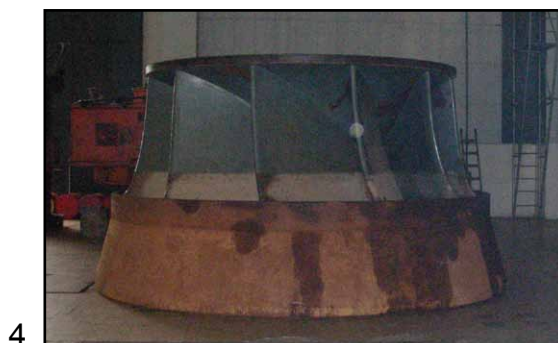
The customer contacted the Distributor in September 2007 for a general inspection of the coating which indicated repair was needed in areas. A proposal to refurbish with Belzona® 1321 has been made.
