## BELZONA EXTENDS CHILLER LIFE

Museum, Kansas, USA

February 2007

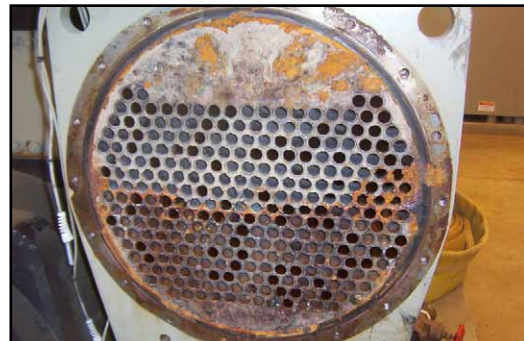
1. Tube sheet before blast cleaning.
2. Grit blasted tubesheet. Damage is very evident.
3. Excess material removed from tube with the smooth side of hacksaw blade.
4. Tube sheet ready for years of trouble free service.
