BELZONA PROTECTS DIFFUSER VANES

Irrigation District- Wyoming, USA

Small hydroelectric plant feeding off an irrigation canal.

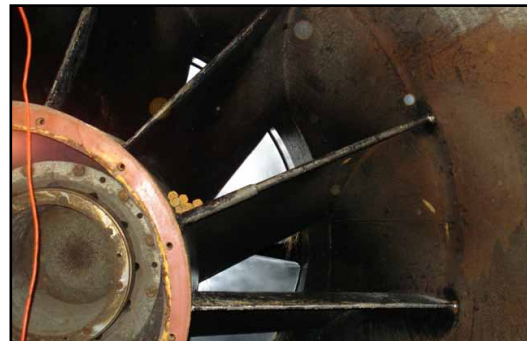
The diffuser vanes were suffering from erosion/corrosion. Previous attempts were made to protect them using coal tar epoxies with limited success.

1. Diffuser vanes before blasting
2. Diffuser vanes after blasting
3. Belzona® 1121 applied to smooth edges
4. Second coat of Belzona® 1321 applied

Application was carried out in accordance with Belzona System Leaflets CEP-3 and CEP-5. Belzona® 1121 was used to smooth out the edges of the vanes to rebuild metal loss. Belzona® 1321 was applied by stiff bristled brush to protect against further erosion/corrosion.
