## BELZONA REPAIRS A VERY LARGE PUMP HOUSING

Power Plant, France

Large cooling water pump housing

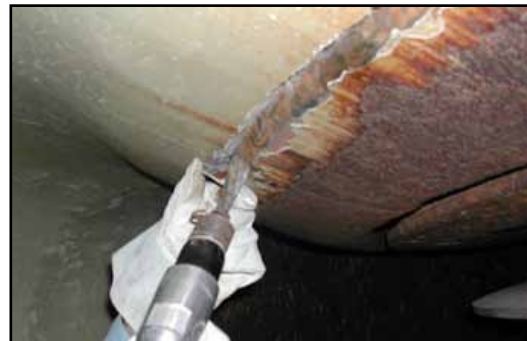
Water infiltration between joint of metal and concrete

1. Application Situation
2. Cleaning
3. Application of Belzona® 1111
