## BELZONA REPAIRS VULCANIZED RUBBER LINED PUMP

Chemical Plant, Italy

Vulcanized rubber lined pump body

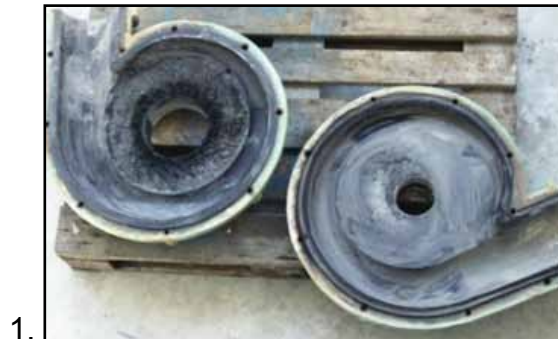
A large area of the rubber had been eroded away.

1. Pump body before application
2. Close up of damaged rubber
3. Upper body after application
4. Lower body after application
