BELZONA REPAIRS BIODIESEL COLUMN

Biodiesel Producer, Memphis, TN

Biodiesel Column

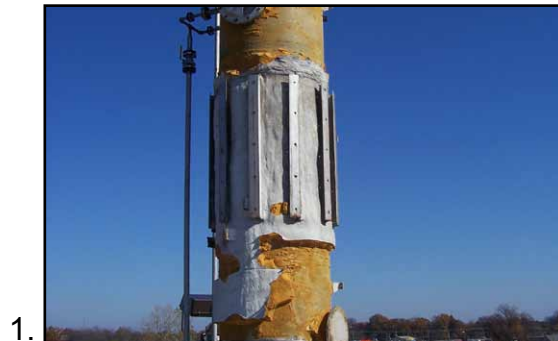
Due to stress on a flange there was a crack at the weld causing Biodiesel to leak. This was 130 feet above the ground.

1. The column to be repaired
2. Column under repair
3. Repaired area on column
4. Repaired area close-up
