BELZONA REPAIRS SCHOOLS CHILLER

Elementary School, St. Louis, Missouri

Corroded chiller face

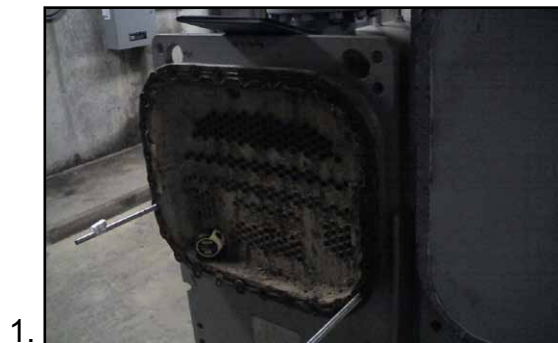
Years of service had caused extensive corrosion on the chiller tube sheet face.

1. Corroded tube sheet face
2. Application in progress
3. Completed application
4. Completed application
