BELZONA PROTECTS CONTAINMENT AREA

Power Project - Bastrop, Texas, USA

Containment area for water treatment chemicals.

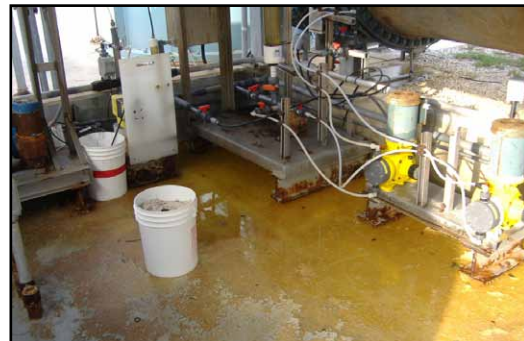
The previous coating had failed causing significant damage to the underlying concrete.

1. Containment area prior to being coated
2. Area prepared and leveled with Belzona® 4111
3. First coat of Belzona® 4311 being applied
4. Completed application
