BELZONA SEALS POROUS TANK WELDS

Herbicide Manufacturer- Bushton, Kansas, USA

Stainless steel herbicide tank

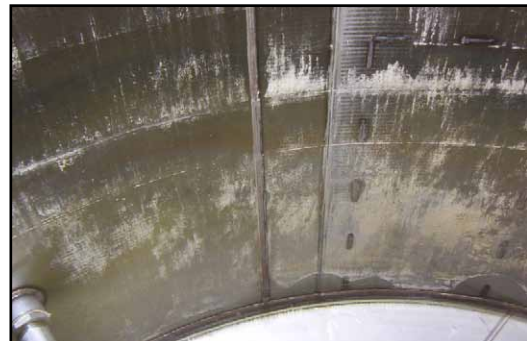
Porous welds in stainless steel tank. Herbicide is expensive and very slippery. Not only was leaking tank an environmental hazard but a general safety hazard as well.

1. Tank interior before application
2. Tank seams coated with Belzona® 4301

Application carried out in accordance with Belzona Know-How System Leaflet TCC-1. The tank was drained and rinsed. A stainless steel tank cleaner was used to clean the surface. After preparing the surface, two coats of Belzona® 4301 were applied to the weld seams.
