BELZONA RESTORES KITCHEN WASHROOM FLOOR

Hospital - Albuquerque, New Mexico, USA

Hospital kitchen washroom floor

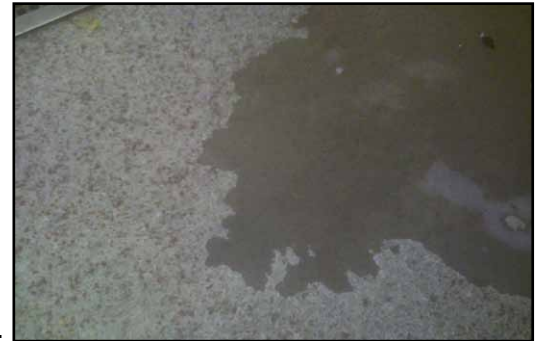
The terrazzo floor had degraded from constant cleaning and contact with cleaning solutions.

1. Close-up of original damaged floor
2. Heavy damage in washdown room
3. Finished floor where washing machine goes
4. Finished floor from outside hallway
