BELZONA PROTECTS IRRIGATION CULVERT

Irrigation District - Wyoming, USA

March 2007

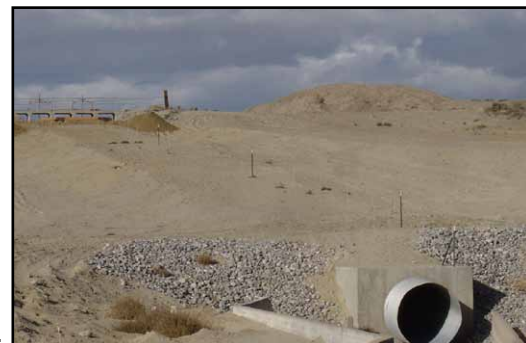
Debris, sand, and silt carried by irrigation water wore through the galvanizing in one season. Left uncorrected, the underlying carbon steel pipe would quickly corrode leading to soil erosion.

1. The galvanized culvert to be protected
2. Belzona® 5811 being applied via airless spray
3. The completed application. Inspected after one season of operation

Belzona® 5811 and Belzona® 9331 were applied in accordance with a modified Belzona Know-How System Leaflet VPF-2.

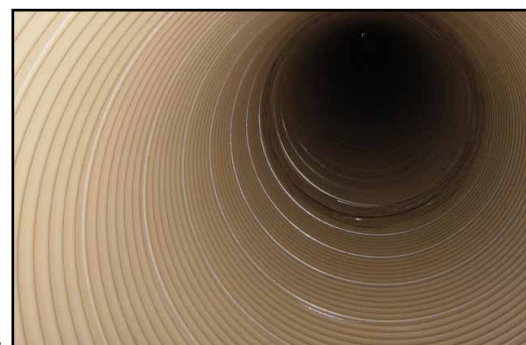
3.

Replacement of the damaged pipe would have cost \$700,000 and taken considerable time to complete. The Belzona repair was conducted quickly in situ and saved the customer \$650,000. Inspected after one season and found to be in excellent condition.
