ACID CONTAINMENT FLOOR RE-HAB WITH BELZONA

Water Treatment Plant, OK

Floor and sump access-way in water treatment plant.

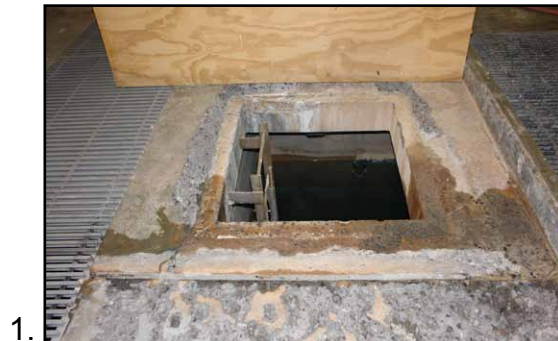
1. Floor prepared for re-surfacing
2. Re-shaping the access opening Belzona® 5811
3. Grey coat over beige with Surefoot added
4. Rebuilt, protected, a first class job!

Application was carried out in accordance with Belzona Know-How System Leaflets FPA-1 & 3. Bulkfill was used to rebuild the sump access and spalled areas. The entire area was then given two coats of Immersion Grade with Surefoot Aggregate applied to achieve safe footing.
