BELZONA UPGRADES WEAR PLATES ON PELTON TURBINE

Hydroelectric Power Plant, France

Pelton Turbine

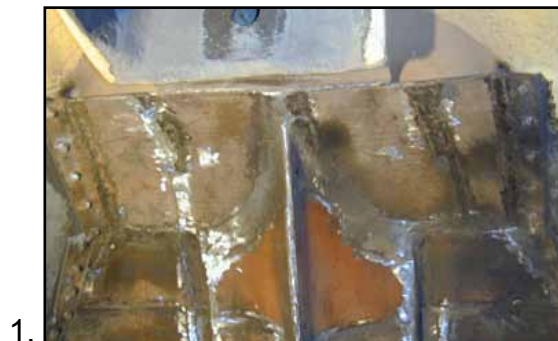
1. Application Situation
2. Weld Failure
3. Belzona® 1812 in Situation

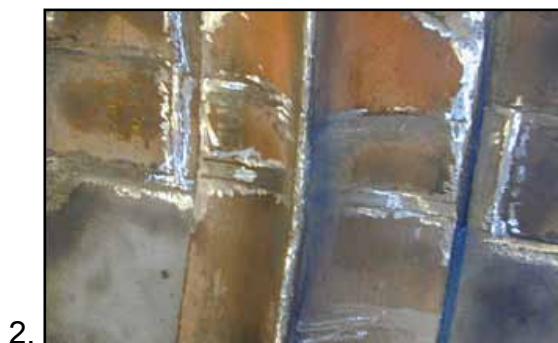
Vibration had lead to weld failure on the splash plates and the anti-wear plates needed replacing

The application was carried out in accordance with modified Belzona Know-How System Leaflets SHM-11 & GSS-9. Belzona® 1311 used to seal around wear plates and Belzona® 5811 was injected into the cavity behind the wear plates. Belzona® 1812 then applied over the top as a sacrificial coating.
