BELZONA PROTECTS SLUDGE PUMP

Wastewater treatment plant, Bulgaria

Casing of a sludge pump

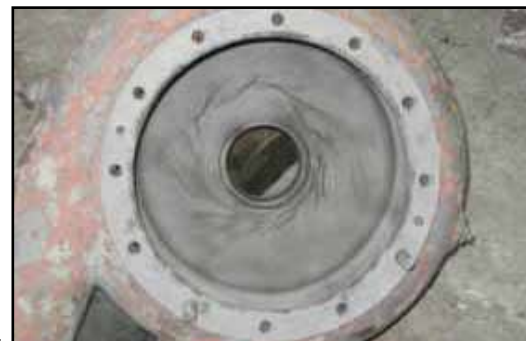
Pump casing severely eroded and corroded during operation.

1. Worn out pump casing.
2. After Belzona® 1321 application.
3. Inspection view 600 working hours after application.

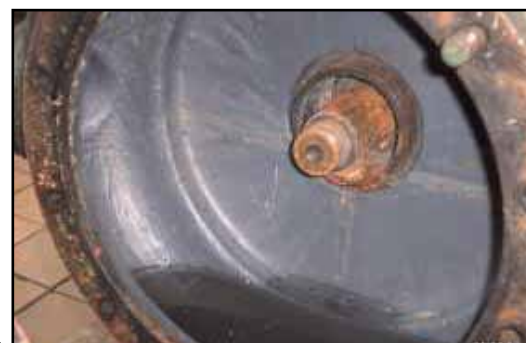
3.

Pump suffered very low efficiency and was considered to be scrapped. Belzona was chosen both on basis of cost and fast turn-round. Inspection after 600 working hours showed the pump casing was still in excellent condition.
