## BELZONA REPAIRS AND SEALS IRON GUTTER

Logistics Factory, Lancashire - UK

Traditional cast iron gutter 0.5 meters wide by 64 meters long

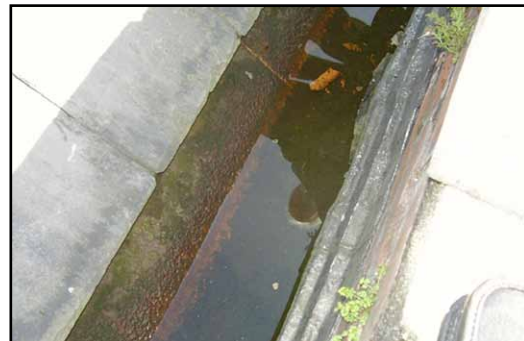
The cast iron had over time corroded and the joints deteriorated allowing water to enter the internal fabric of the building.

1. Blocked and corroded gutter
2. Gutter drained ready for preparation
3. Belzona fully reinforced Flexible Membrane system
4. Completed application
