## BELZONA SEAL TO DRYER CAN SAVES MONEY

Paper Co. Jackson, Alabama

Dryer can of paper machine.

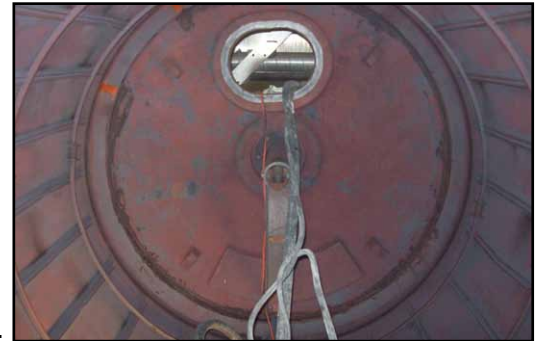
Gasket of dryer can failed and allowed steam to escape. Losing steam means losing money.

1. Start of job
2. Surface around joint grit blasted
3. Application of Belzona® 1321
4. Application of Belzona® 1311 to complete the repair

Application was carried out in accordance with a modified Belzona Know-How System Leaflet GSS-6. After grit blasting, a 2 band of Belzona® 1321 brush applied followed by Belzona® 1311 pressed firmly into the seam where the gasket had failed. "
