## BELZONA SEALS UNSANITARY LEAKING FLOOR DRAIN IN FOOD PLANT

Waste drain on 2nd floor above production packing area.

Leak around drain allowed waste product into the sanitary production packaging floor below.

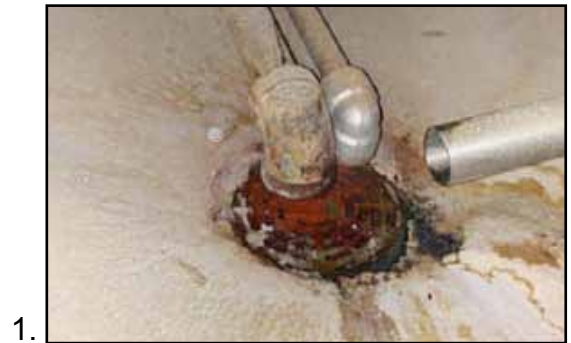
1. Unsanitary, leaking drain
2. Surface prepared
3. Belzona® 4111 installed
4. Drain cover installed
