## BELZONA REPAIRS RUBBER LINED BRINE TANK

Paper Mill, Alabama

Rubber lined brine tank in ower house of paper mill

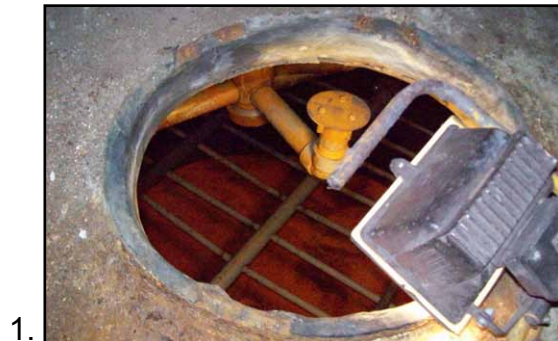
1. Opening to the tank
2. Exposed metal where repair to be made
3. Conditioner applied after grinding
4. Repair completed with Belzona® 2111

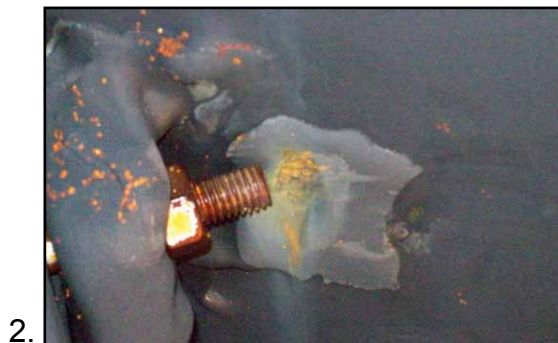
Rubber lining had been damaged locally. It was too costly to get specialist tank repair company to come and make repair.
