BELZONA SEALS CHEMICAL BUNKERS FROM THE ENVIRONMENT

Fertilizer Plant, North Alabama USA

Underground fertilizer storage bunker

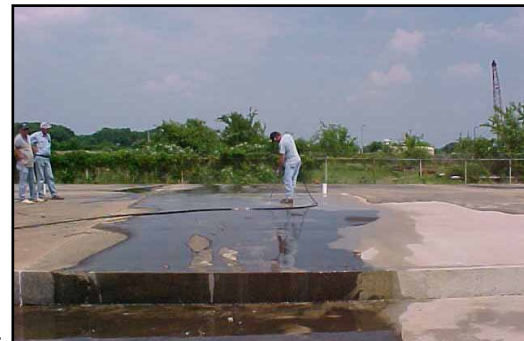
1. Cleaning the concrete
2. Overall view of cracks conditioned with Belzona® 3911
3. Joints and cracks sealed with Belzona® 3111
4. Spraying coat of clear cladding

Application was carried out in accordance with a modified Belzona Know-How System Leaflet RPA-1. Surface prepared by pressure washing then all cracks and joints sealed with Belzona® 3111 system. A coat of clear cladding was applied over the entire concrete storage area.

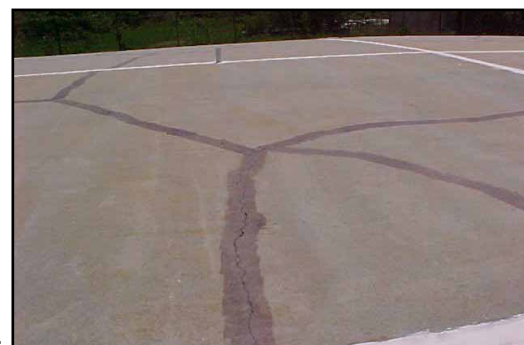
2.

Water was penetrating into the expansion joints and cracks, reacting with old fertilizer which could cause further concrete failure and chemical release into the environment.
