NASA GOES WITH BELZONA

NASA, Alabama USA

Machine shop floor was uneven.

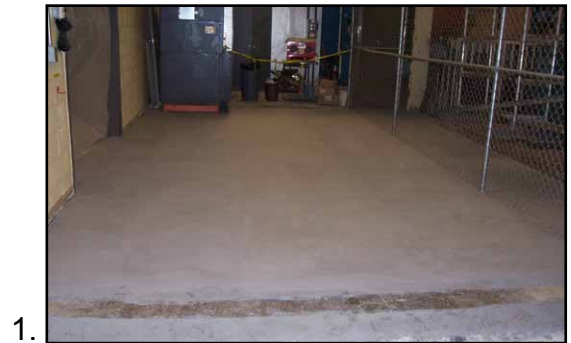
1. Overall view of the floor after preparation by Blastrack
2. Screed box laying out the Belzona® 4131
3. Smoothing out the Belzona® 4131
4. Final coats of Belzona® 5231

Application was carried out in accordance with Belzona Know-How System Leaflet FPA-1. A screed box was used to apply 1/4 inch of Belzona® 4131. After the floor was leveled out Belzona® 5231 was applied in two coats.
