BELZONA COATS RISER IN SPLASH ZONE

Offshore Platform, Thailand

Corroded riser pipe

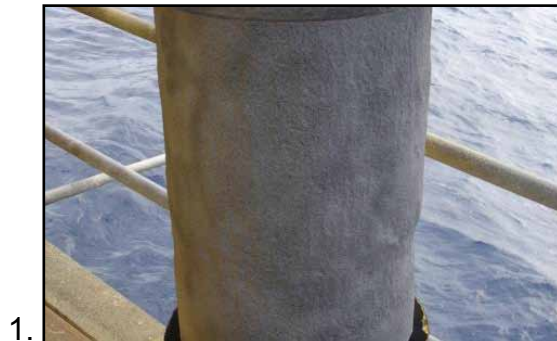
The offshore platform was experiencing severe corrosion and wall thickness loss of the riser pipe due to the splash zone area which may ultimately lead to leaks or rupture of the high pressure pipe.

1. Corroded riser pipe
2. Application of Belzona® 5831
3. Completed application
