BELZONA REPAIRS OIL TANK LEAK

Oil Refinery, Thailand

Leaking Oil Tank

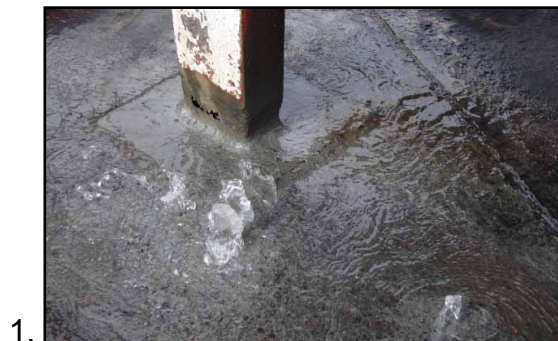
The roof deck of the tank had been subjected to severe corrosion leading to a local leak of the oil vapour. This was very hazardous to the plant operation and there was also a risk of rain water contamination into the tank.

1. Leaking oil tank
2. Prepared application area
3. Applying Belzona 1161
4. Applying Belzona 5831
