BELZONA GETS TRACTOR BACK ON TRACKS

Rubber tractor tracks

Abrasion of rubber on inside surface of tracks

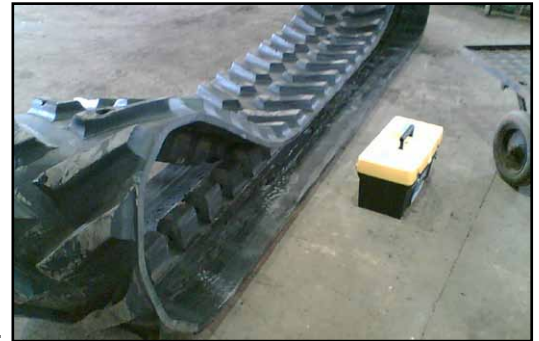
1. General view of track before repair
2. Close up of damaged area
3. After repair
4. Back on track
