## BELZONA RESTORES SAFETY VALVE SEAL

Power plant, Bulgaria

Safety valve in cooling water system

Damaged mating surface in the safety valve was allowing back-flow of water

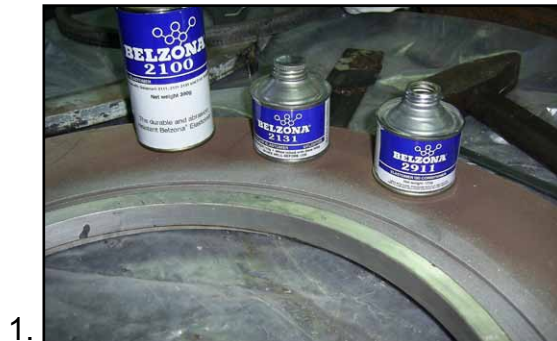
1. The safety valve plate
2. The inner and outer forming rings put on the valve plate
3. Belzona® 2131 poured in the gap between two forming rings
4. The top forming plate clamped to form precise mating surface
