BELZONA SEALS PAPER MACHINE LEAKS

Paper Mill, Poland

Paper Machine casing

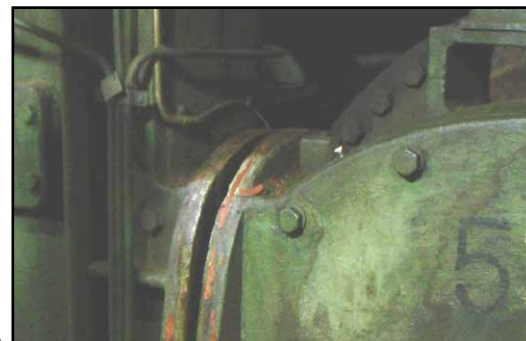
Leaking crank casing due to inadequate sealing. Significant oil losses necessitated repairs several times per year.

1. The leaking casing
2. Repair using Belzona® 2211
3. Belzona® 2211
4. Final repair situation
