## BELZONA PROTECTS VERTICAL LIFT PUMP IMPELLER

Open-faced vertical lift pump impeller

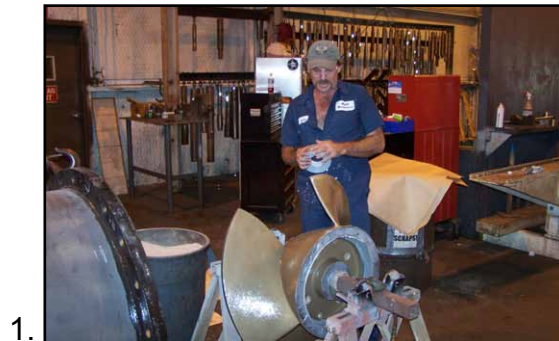
1. Vertical lift impeller with Belzona® 2941 conditioner applied
2. Inspection of impeller during coating process
3. Coating completed, awaiting installation

Application was carried out in accordance with Belzona Know-How System Leaflet CEP-3.
