BELZONA PROTECTS WASTEWATER PUMP

Chemical Co, Texas

Wastewater pump in chemical company was experiencing severe corrosion from chemical attack.

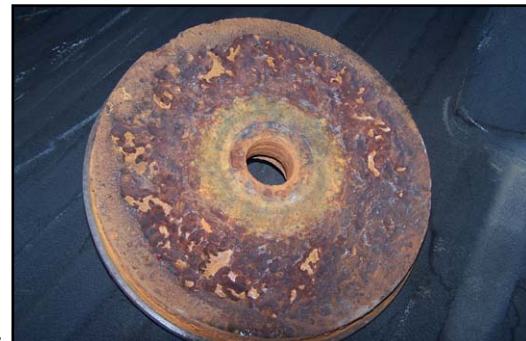
Strong chemicals within the wastewater process were attacking pump components which caused pitting and degradation of the carbon steel substrate resulting in loss of performance, loss of pump efficiency and frequent pump replacement.

1. Damaged wastewater pump head
2. Pump head rebuilt and coated
3. Damaged pump housing
4. Pump housing rebuilt and coated
