## BELZONA REPAIRS GEAR BOX OF DREDGER

Dredger, Egypt

Gear Box of dredger cutter shaft.

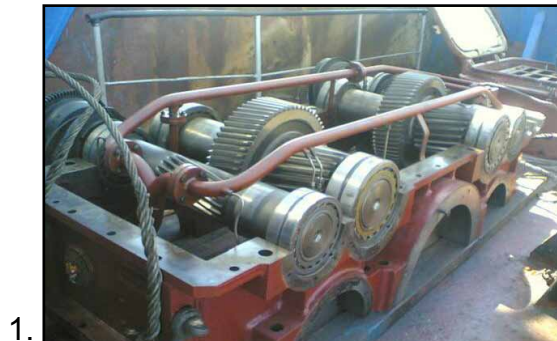
1. View of the dredger cutter shaft gear box
2. Worn out bearing housing
3. Form was applied, then Belzona injected through the former
4. Gear box bearing housing perfectly rebuilt

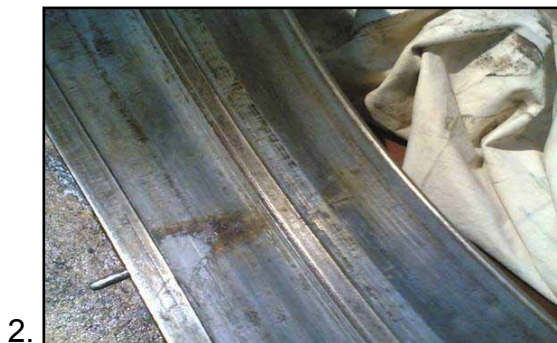
Bearing housing of the gear box was badly worn due to bearing failure.

Belzona successfully repaired the bearing housing insitu without machining which would have been difficult due to the large size of the gearbox.
