BELZONA ENHANCES PUMP EFFICIENCY

Double end suction centrifugal water pump

General erosion/corrosion damage leading to reduced pump efficiency

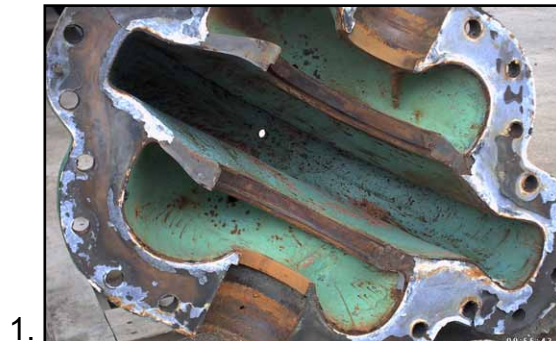
1. Surfaces before application
2. Preparation of the casing
3. Two coats of Belzona® 1341 applied
4. Inspection view after a year in service

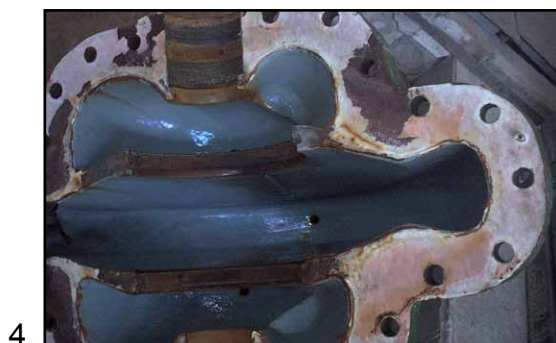
As a result of applied efficiency enhancement coating and further sealing rings seat repair, reduced power consumption was registered and efficiency increased by 9.91%. The inspection after 12 months in service shows the perfect condition of the applied coating.
