BELZONA RESTORES AND PROTECTS RIVER WATER PUMP

Petrochemical Plant, Louisiana U.S.A.

Cooling water pump drawing water from the Mississippi river.

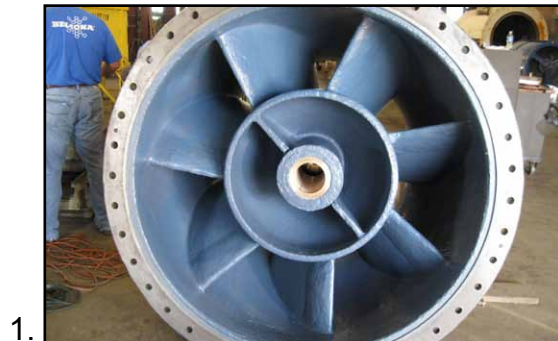
Pump was experiencing corrosion and cavitation erosion damage. Much of the casing was suffering from pitting caused by impingement.

1. Rebuilt and protected suction bell
2. Impeller with first coat of Belzona® 1321(Grey)
3. Impeller fully protected with second coat Belzona® 1321
4. Suction diffuser fully restored

Belzona® 1111 (Super Metal)

Belzona® 1321 (Ceramic S-Metal)
