BELZONA SEALS UPPER FLOOR PUMP ROOM

County Hospital, Colton California U.S.A.

Pump room at hospital positioned on floor above computer room.

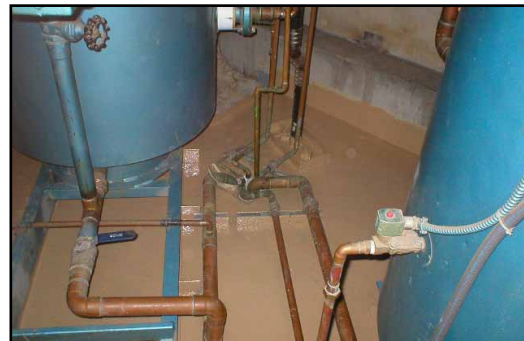
Copper pipes leaking water on the floor was leaking through the concrete to the lower level.

1. The pump room showing the pipes that keep leaking
2. Reinforcement tape used for edges
3. Back of pump room
4. Finished floor

Application was carried out using a modified Belzona Know-How System TCC-15. After washing and removing dirt from floor Belzona® 5811 was used to coat the entire floor plus 6 inches up the wall to completely encapsulate the area and to form a containment area.
