BELZONA PROTECTION OF CO₂ COMPRESSOR

Soda plant, Bulgaria

100,000 m³/h multistage centrifugal compressor of CO₂ for Sodium Carbonate production

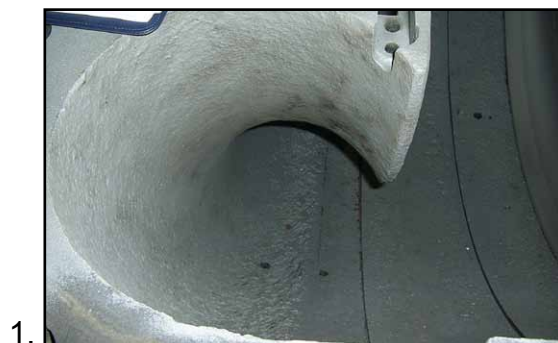
Erosion/corrosion damages on the outlet section due to high temperatures (110°C), water injection and acid contaminated flue gas.

1. Erosion/corrosion damage to the internal surfaces reviewed after blasting
2. Belzona® 1392 applied
3. Belzona® 1311 used to fix the stainless steel plates
4. View of the protected internal profile after 2,000 working hours in service of application made in 2005

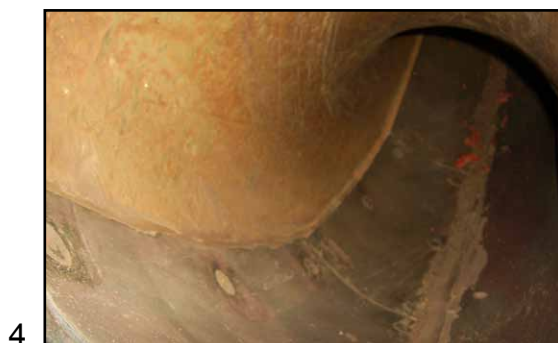
No other effective alternative available. Stainless steel cladding was fit on the most damaged sections using Belzona® 1311 to provide further protection. Inspection after 6 months and 2,000 working hours of the unit reviewed only slight discolouration and loss of gloss. According to this application method five compressors have been protected in the plant.
