BELZONA REBUILDS AND PROTECTS EXHAUST ON YACHT

Shipyards, Monaco

Luxury yacht in dock for routine repairs and inspection.

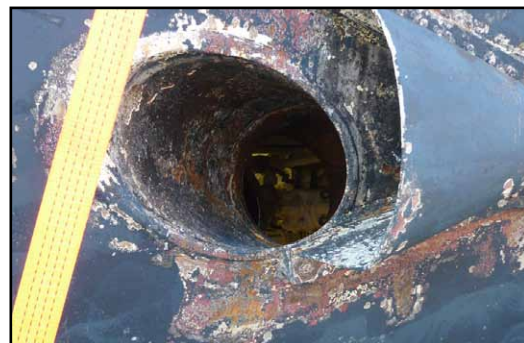
Severe corrosion caused by hot exhaust gas and salt water, led to critical loss of steel.

1. The yacht in dock
2. Initial state of exhaust pipe
3. Pitting clearly evident after blasting
4. Final result after rebuilding with Belzona® 1511 and coating with Belzona® 1391
