BELZONA COATS CROSSOVER FLOOR

Car Manufacturing Plant, Alabama USA

Replace existing floor coating to high traffic crosswalk.

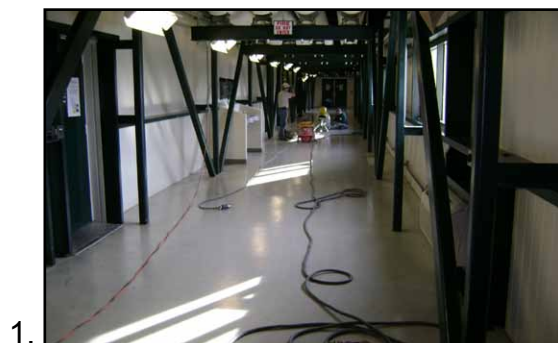
1. Removing the existing floor coating
2. Applying first coat of Belzona® 5231
3. Applying second coat of Belzona® 5231
4. Completed application

Application was carried out in accordance with Belzona Know-How System Leaflet FPA-3. Existing coating was removed using a walk behind floor grinder before applying the Belzona® 5231 system. applicators used spiked boots to aid access.
