BELZONA REBUILDS CONTACT AREA ON RUDDER ASSEMBLY

Ship Dockyard, Bulgaria

Rudder stock to rudder blade flange coupling

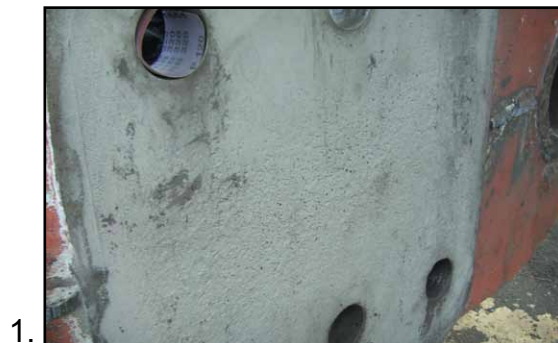
Lost contact area due to ingress of sea water after bolt connection failure

1. Badly corroded flange of the steering blade
2. Forming plate placed to form the flange
3. The blade ready to be assembled
4. Assembly ready to be bolted up

Application was carried out in accordance with Belzona Know-How System Leaflet GSS-8. Steel plate treated with Belzona Release Agent was used to form the Belzona® 1111 on the flange face. This new face was then used to reform the rudder stock flange face.
