UNIVERSITY STUDIES BELZONA FLOOR SOLUTION

University, St Louis, Missouri U.S.A.

Floor areas in service areas/boiler room.

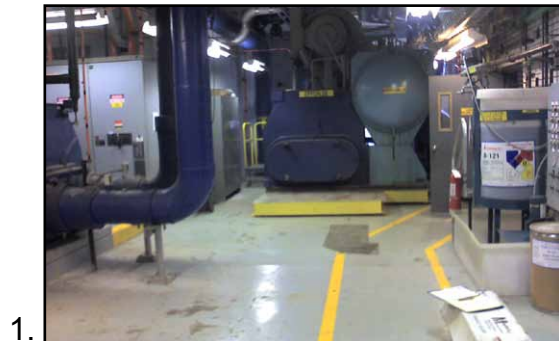
Floor caused trip hazards for employees and previous coatings required annual refurbishment.

1. Floor before repairs and coating
2. Close up of floor problems
3. Holes in floor repaired with Belzona® 4111
4. Floor after coating with Belzona® 5231
