BELZONA 4181 TAKES THE HEAT

Chemical plant, Memphis, Tennessee U.S.A.

December 2007

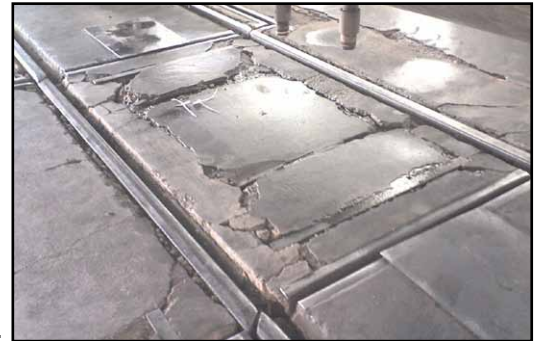
1. Overview of the rail car unloading station
2. Eroded concrete in the sump
3. Belzona® 4181 being troweled onto the concrete surface

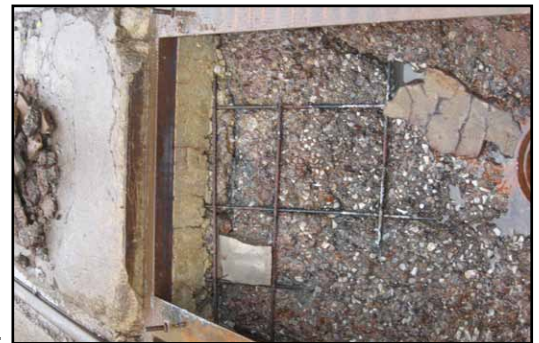
2.

Concrete was eroding away due to steam and chemical wash downs.

Previous grouts and coatings had failed due to the steam and hot water. Belzona® 4181 provides outstanding resistance to the chemicals and heat in this environment.
