## BELZONA RESTORES STEEL MILL FLUME

Badly eroded waste flume at a steel mill.

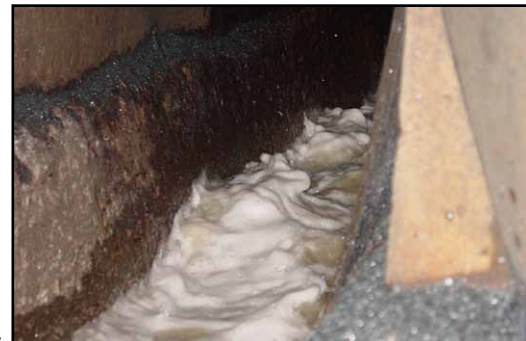
Highly abrasive waste material was rapidly eroding the flume, carving out a larger cross-sectional area than original designed. Flow velocity dropped as a result and the flume was not longer functioning as designed thus allowing build up of waste within the flume.

1. Trough prior to surface preparation
2. Trough profile reformed with Belzona
3. A further quarter inch of Belzona® 4111 applied
4. Trough fully coated with Belzona® 1812
