BELZONA REPAIR AND PROTECTION OF DESALTER

Petroleum Company, Egypt.

December, 2008

Desalter

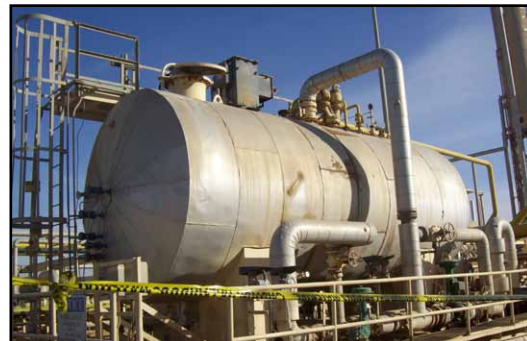
1. General view of the Desalter
2. Rebuilding the pitting areas in the lower half
3. Finishing the coating of the upper half
4. Application completed

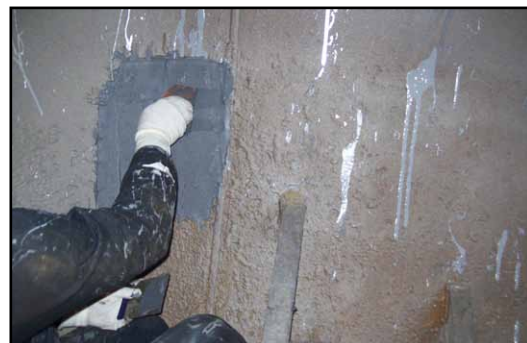
2.

Several pitted areas in the lower half of the vessel needed to be rebuilt. Protection then required particularly for high salt levels in lower half of vessel.

Application was carried out in accordance with Belzona Know-How System Leaflet TCC-5. After filling the pitted areas using Belzona® 1311, upper half of vessel protected with Belzona® 5891 and Belzona® 1391 applied to the lower half.
