## BELZONA SEALS CONCRETE COOLING TOWER BASINS

Chemical Plant, West Tennessee USA

2008

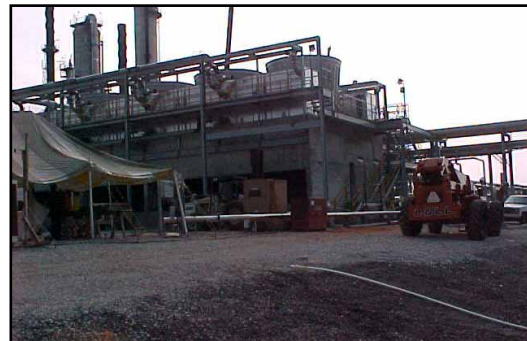
Concrete Basins in cooling tower were leaking shortly after the start up of a new unit.

1. Cooling Tower overview
2. Walls repaired with Belzona® 4111
3. First coat of Belzona 5811 being applied
4. Final Coat of Belzona 5811 applied

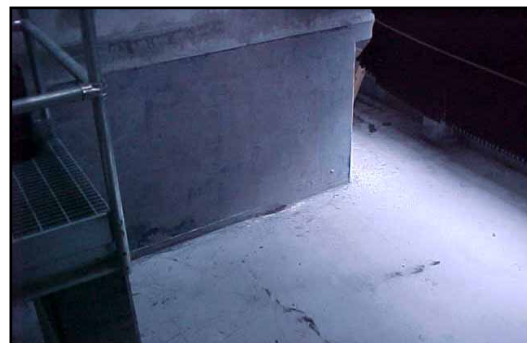
2.

Cracks in the concrete were allowing water leaks into the environment.

Application was carried out in accordance with Belzona Know-How System Leaflets HEX-6 and -7. After grit blasting the concrete, cracks were sealed with Belzona® 4111 then coated with a reinforced Belzona® 5811 system. The entire basin was then coated with Belzona® 5811.
