## BELZONA REPAIR OF CONDENSATE TANK

School, Kansas City

Leaking condensate return tank

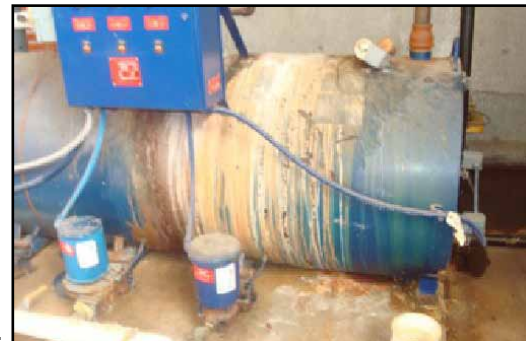
During summer maintenance of this facilities boiler plant, the condensate return tank was found to be severely corroded and leaking, with concern for its ability to make it through another heating season.

1. The leaking tank
2. Rolled plate
3. Plate bonded with Belzona® 4181
4. Completed application

Application was carried out using a modified Belzona Know-How System Leaflet TCC-1. The tank was lifted for access and mechanically prepared with the MBX Bristle Blaster. A heavy gauge steel plate was fabricated and bonded into place with Belzona® 4181. Belzona® 1311 was then used to reinforce the tank ends.
