STORM WATER PUMP PROTECTED WITH BELZONA FOR 10 YEARS

City Authority, South Eastern Virginia, USA

Replacement new vertical storm water pump

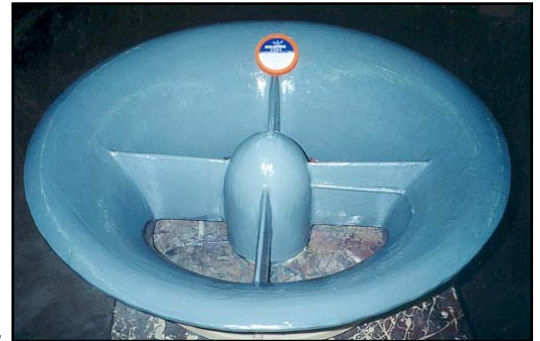
1. Suction Bell coated in 1998
2. Diffuser coated in 1998
3. Suction Bell in 2008
4. Diffuser in 2008

Application was carried out in accordance with Belzona Know-How System Leaflets CEP-3 and CEP-4. New pump was disassembled at local repair facility. Suction bell and diffuser blasted and coated with Belzona® 1321 internally and Belzona® 5811 externally.

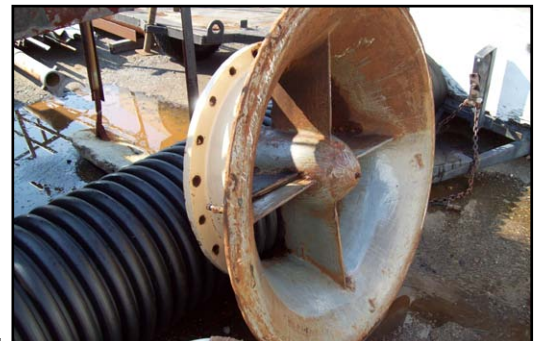
3.

City personnel were very unhappy with the short service life of original vertical storm water pump. To protect the new pump from the damaging effects of the erosion corrosion cycle, Belzona coatings were applied. The new pump was retired after 10 years of successful service to replace it with a larger pump. An after service inspection revealed that 100% of the Belzona® 5811 was intact and 95+% of the Belzona® 1321 was intact.
