## BELZONA KEEPS THE LIGHTS BURNING

Power Station, Western Australia

Bushing of both blue and red phase of 330KV oil filled transformer. This is a major unit responsible for power supply to a major part of the city.

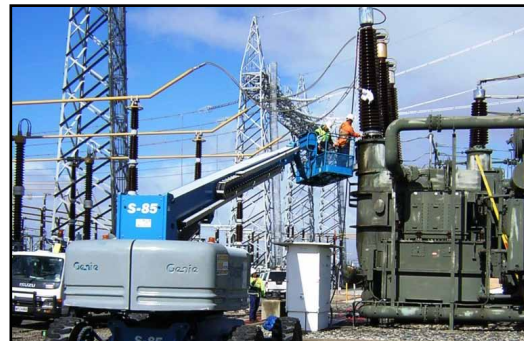
1. General view of site with access from mobile platform
2. Application of Belzona 1161 applied in conjunction with Reinforcement tape
3. Completing the application
