## BELZONA OPERATES IN THE DESERT

Gas Pipeline, Tunisia

Gas transmission pipeline operating at pressure of 1300psi

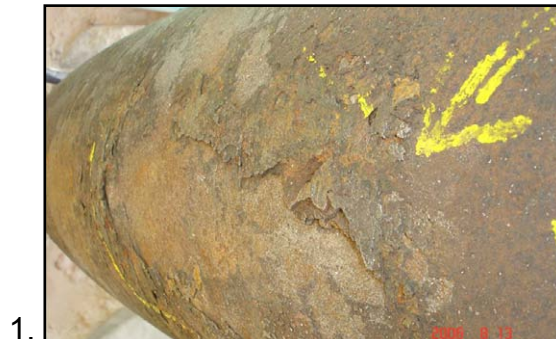
Pipeline was highly corroded due to external corrosion. Over 60% wall loss was measured on the pipe. Isolating the pipe to change this corroded section would cost millions in production loss.

1. Corroded pipeline before blasting
2. Blasted substrate
3. Application being carried out
4. 2 years later

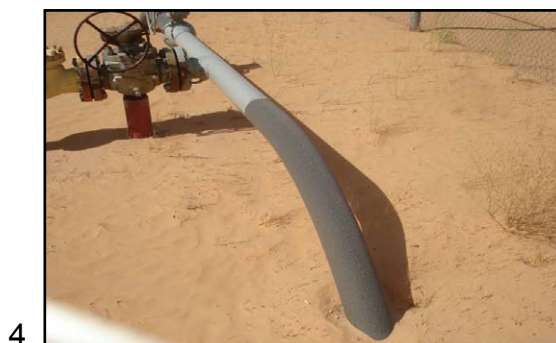
This repair was completed online and with ambient temperature of 55°C (131°F), and avoided production losses. Following this application, an independent inspection company has approved the repair. 2 years later, the pipe is still in perfect condition and the customer is considering extending the Belzona solution to other sections of the pipeline.
