## TANK BASE SEALING WITH BELZONA

Power Station, Portland, Philadelphia USA

Oil storage tank.

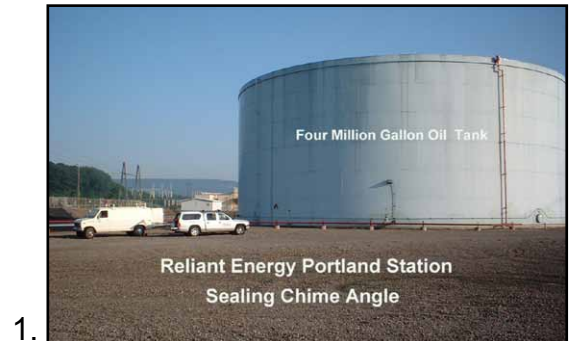
1. View of the tank
2. Chime angle before application
3. & 4. Finished application

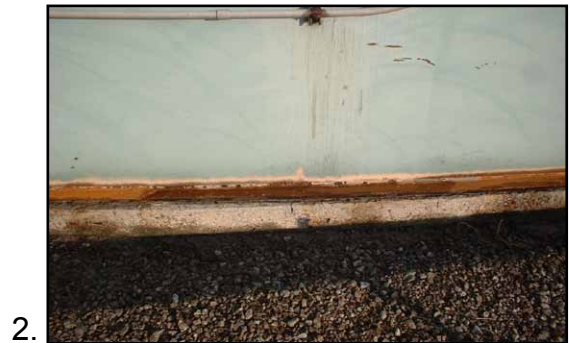
Corrosion at chime angle and water getting under the tank bottom

Belzona® 3111 (Flexible Membrane)

Application was carried out in accordance with Belzona Know-How System Leaflet GSS-3.
