BELZONA REPEAT APPLICATION ON PUMP DIFFUSER

Pump diffuser and cover

Corrosion protection and efficiency enhancement of equipment

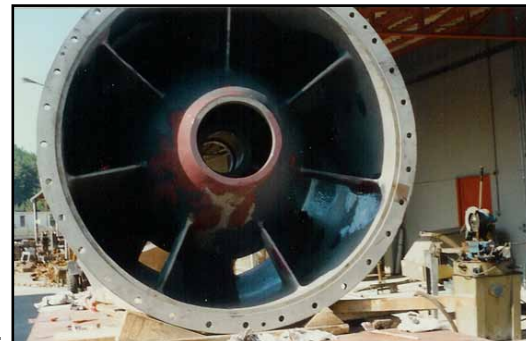
Pump originally protected in 1985 with Belzona Erosion Corrosion Barrier (EC Barrier). The Belzona EC Barrier was still in good shape after the first application which was carried out in 1985 but in need of upgrade to enhance efficiency.

1. Belzona EC barrier after being in service for 22 years
2. Belzona® 1311 used to resurface small areas
3. Completed application of Belzona® 1341
4. Application of Belzona® 5811 on Cover
