## POWER COMPANY APPROVES THE BELZONA SOLUTION

Nuclear Power Plant, France

Protection of an impeller from cooling water system.

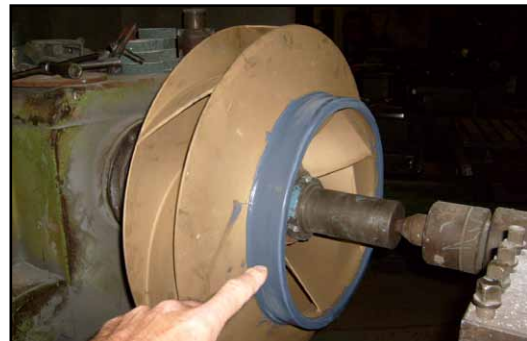
1. Commencement of application with Belzona® 1321 applied to wear ring
2. Application of the first coat of Belzona® 1341
3. Completed application with wear ring machined to size

Application carried out in accordance with Belzona Know-How System Leaflet CEP-3. Impeller surfaces protected with Belzona® 1341 and Belzona® 1321 applied to wear ring and machined to size.
