TIRE REPAIR WITH BELZONA ELASTOMER

Processing plant, Bulgaria

Rear tire of front end loader.

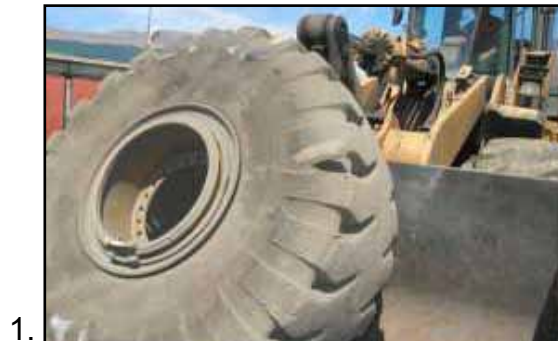
1. Size of the tire clearly evident
2. The metal alongside and the damage it caused
3. Prepared and conditioned area
4. Finished Elastomer repair

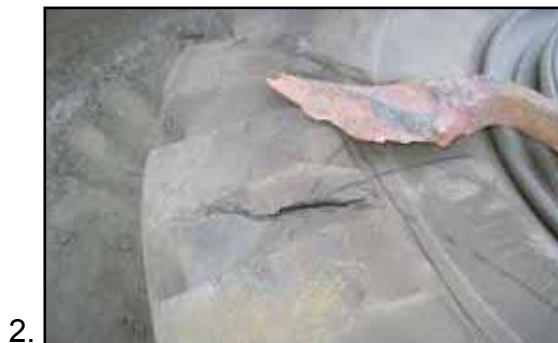
A piece of metal penetrated the sidewall.
