BELZONA PROTECTS CAUSTIC CONTAINMENT AREA

Power Plant, Alabama USA

Caustic Containment Area in water treatment plant.

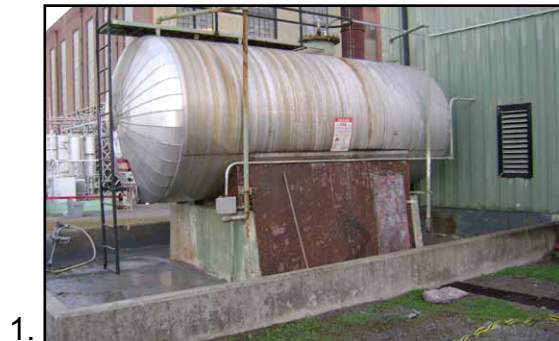
Customers Caustic Containment Area coating had failed and needed a new impervious coating installed.

1. Containment before old coating removed
2. Containment after old coating removed
3. & 4. Completed application

Application was carried out in accordance with Belzona Know-How System Leaflet TCC-15. Old coating was removed using high pressure water blasting. Belzona® 5811 was applied to both containment and tank stands.
