PINTLE REPAIR WITH BELZONA

Pintle housing on cargo ship.

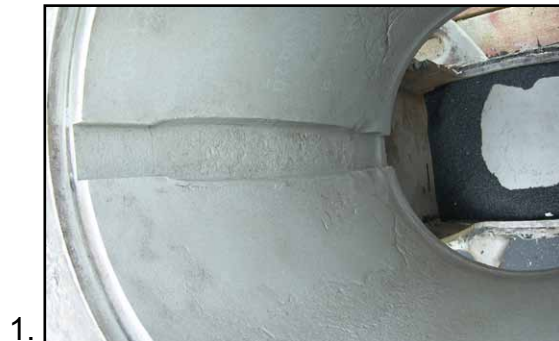
The keyway was damaged by galvanic corrosion and in certain areas the damage reached 40mm in width. Corrosion pitting was severe, up to 12 mm deep in the tapered housing.

1. Prepared Surface
2. Application of Belzona to housing
3. Rebuilt keyway and housing surfaces
4. Fitting the Pintle

Application was carried out in accordance with Belzona Know-How System Leaflet SOS-3. The keyway channel on the rudder was infilled and a new channel machined at 180°.
